NANT YR ABER REVETMENT REPAIR 2019, DECAY UPDATE JANUARY 2025.

Project title: Foot Path 55 Nant yr Aber Caerphilly

Drawing title: River Bank Reinstatement

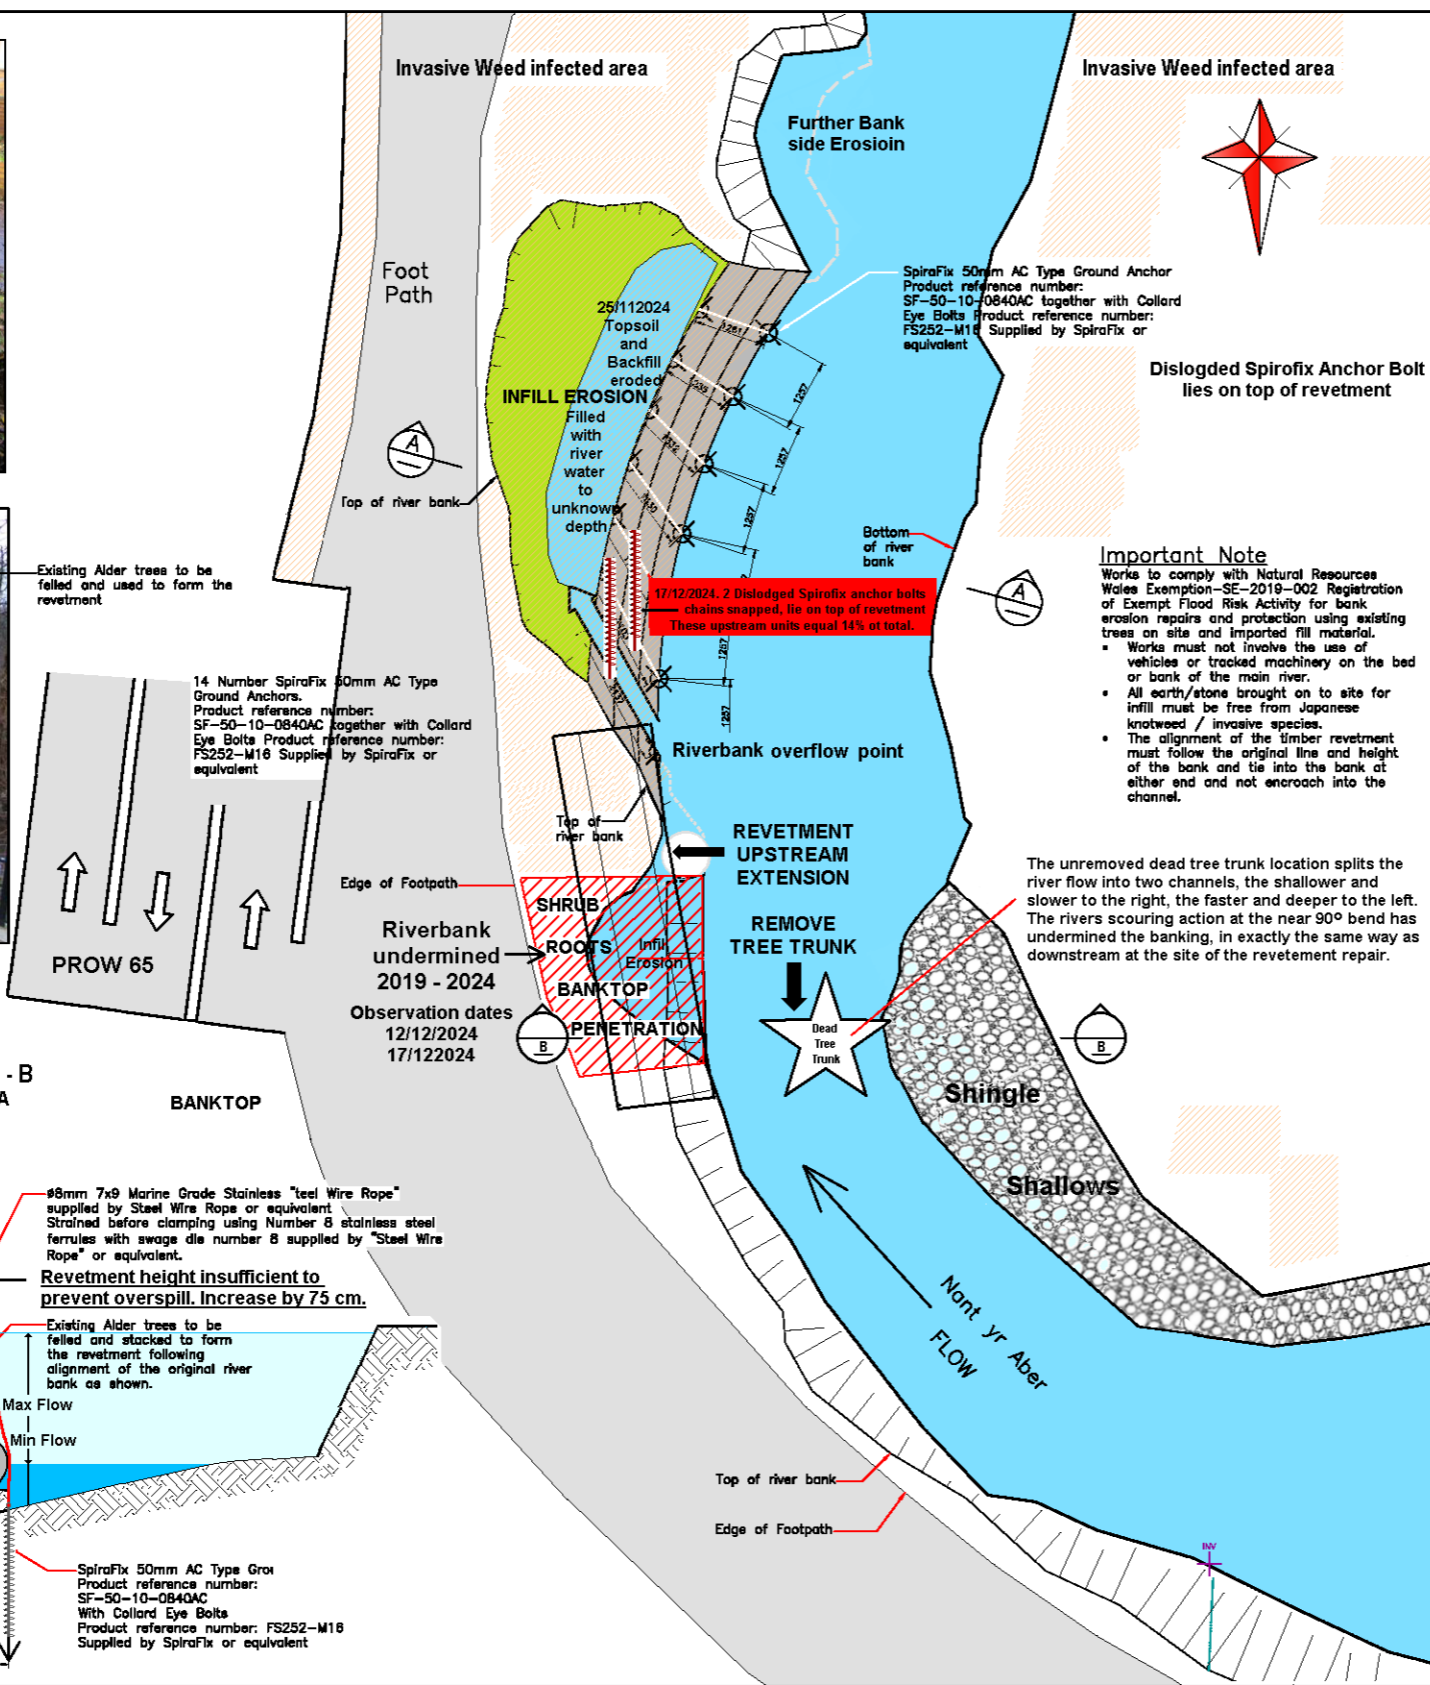
1. The western bank side is on a near 90° bend of soft marl that does not appear to have been taken into account, nor the effects of bank side root penetration.

2. Or the presence of a mid stream dead tree trunk affect on river water flows.
 3. Plus the overall length and height of the revetment repair to repel river overflow.

4. The security of the anchor bolts used. 14% now failed, places increased pressure on the remaining anchor bolts.
 5. For these reasons there is now a need to extend bank side revetment upstream by both height and length.

The amended plan above indicates the failings that have arisen in the five years following completion of the revetment repair.

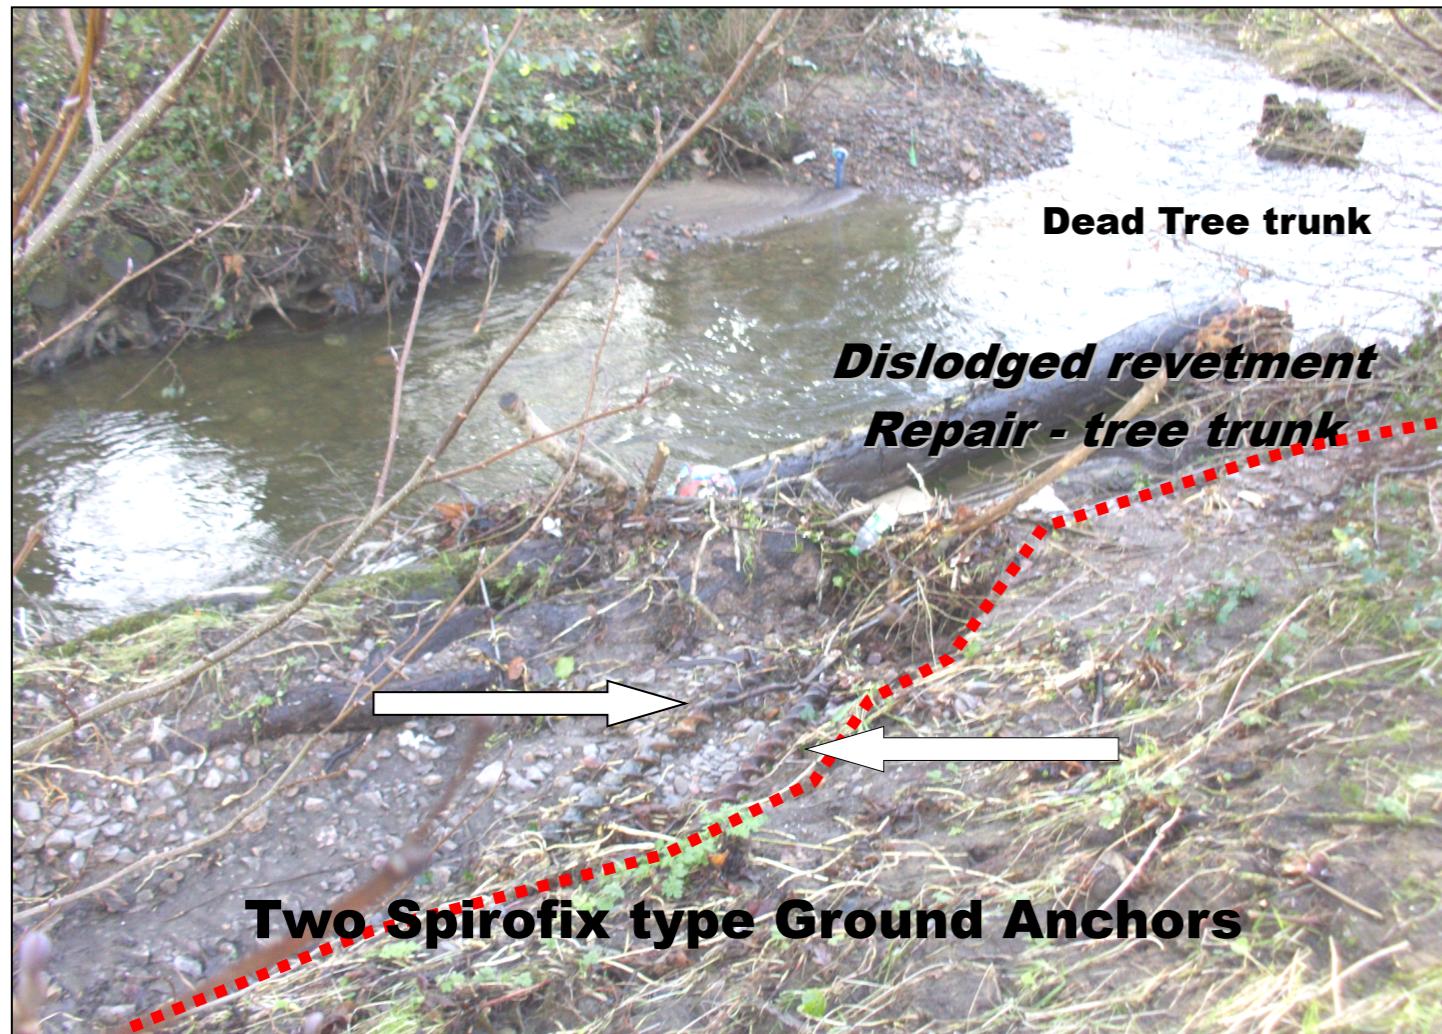
To the left of the hatched red line in the picture above, shows evidence of the river revetment bank exposure and backfill erosion depth of around 80cm, of the certified weed free soil plus backfill material.

It would appear that the '*Dislodged revetment repair tree trunk*' that had lain across the river, has been manoeuvred back alongside and re-strapped to the repair.

The two white arrows point to the two of the Spirofix type revetment ground anchor bolts dislodged by the erosive action of the Nant Yr Aber River. Zoom in for clarity.

On the right of the red hatched line, on remaining foreground soil, the over winter dead stalks of Himalayan balsam spread lie flattened from the constant river overflows, where the 2019 planned bank side repair which was then, and even now is still to low.

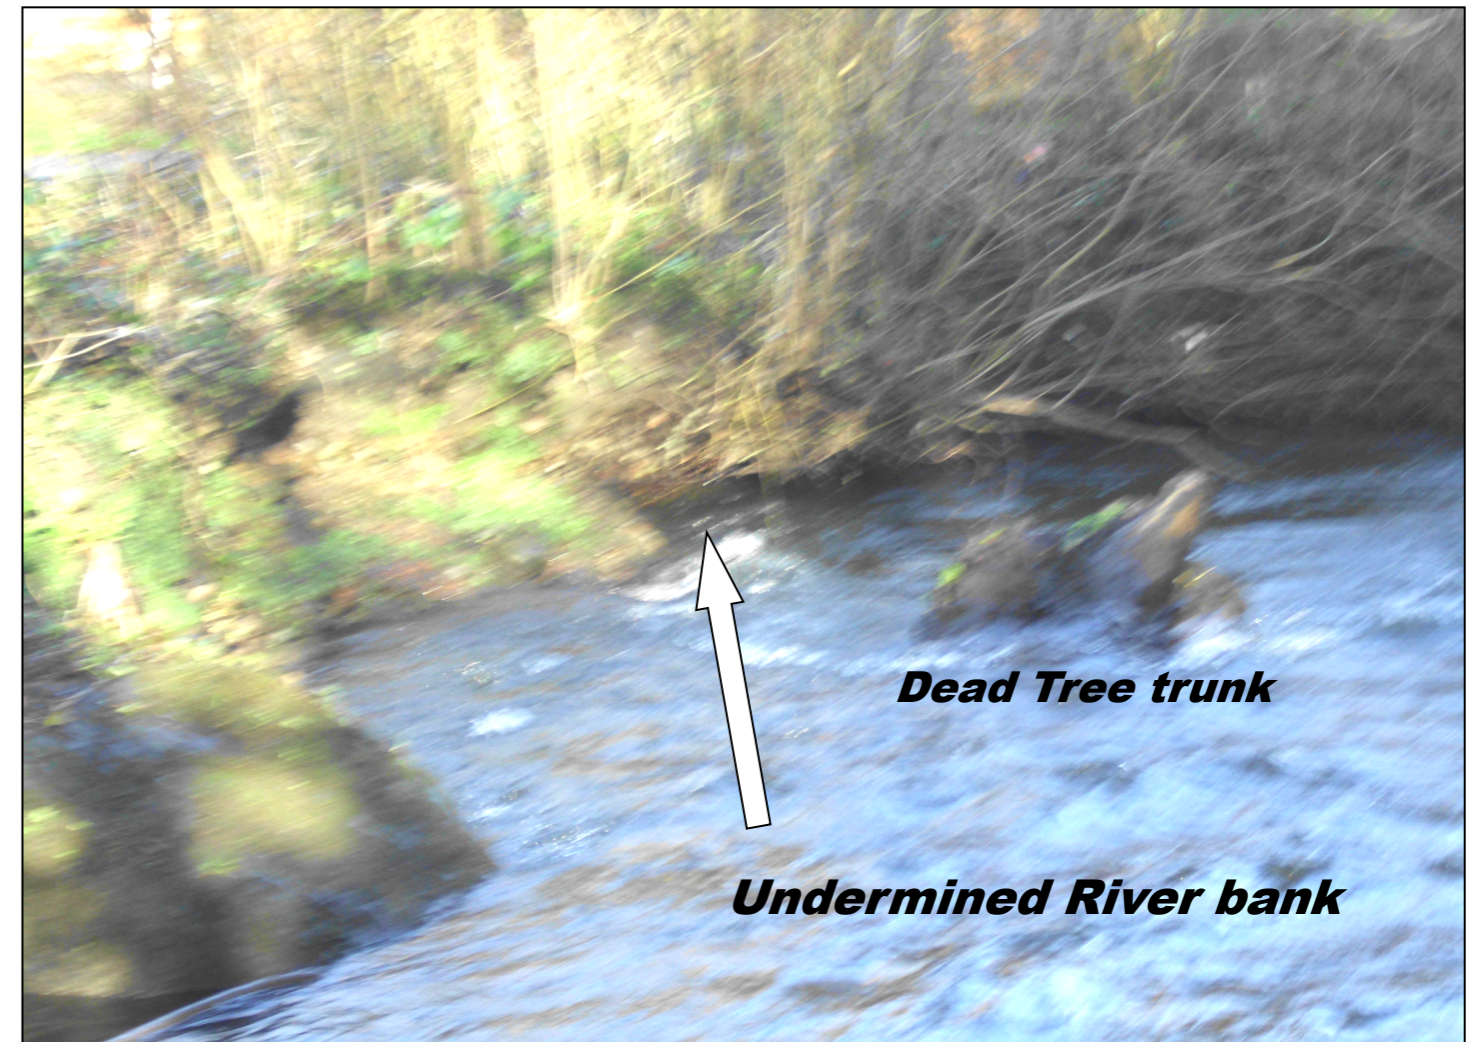
In the picture above the central white arrow shows evidence of the riverbank side's marl type of soil, is constantly undermined from the increased river flow forced by dead tree trunk.

That erosion extends around 1000mm backwards under the surface vegetation growth, whose roots dangle down through the eroded bank into the river water, weakening the bank side structure next to the public footpath.

The rate of erosion becomes more intense after heavy rainfall that increases the rivers depth and metres per second flow speed.
