NANT YR ABER REVETMENT REPAIR 2019, DECAY UPDATE JANUARY 2025.

Project title: Foot Path 55 Nant yr Aber Caerphilly

Drawing title: River Bank Reinstatement

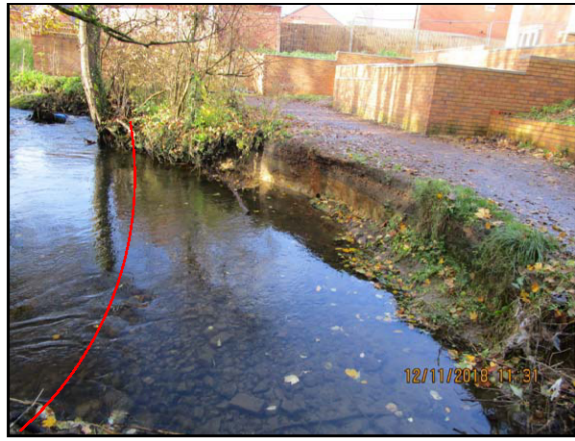
- The scenarios of all rivers undergo constant change from variations in weather patterns.
- The Nant Yr Aber River is no different.
- Where bank side erosion occurs to one side, shallows occur on the other.

- Indicators are always present, but if not understood will aggravate planned resolution outcomes.
- The CCBC revetment repair plan drawing alongside reveals errors that were not foreseen or adequately taken into consideration.

1. The western bank side is on a near 90° bend of soft marl that does not appear to have been taken into account, nor the effects of bank side root penetration.

2. Or the presence of a mid stream dead tree trunk affect on river water flows.
 3. Plus the overall length and height of the revetment repair to repel river overflow.

4. The security of the anchor bolts used. 14% now failed, places increased pressure on the remaining anchor bolts.
 5. For these reasons there is now a need to extend bank side revetment upstream by both height and length.

The amended plan above indicates the failings that have arisen in the five years following completion of the revetment repair.

6. These failings may regrettably increase without proactive input from Natural Resources Wales and CCBC corrective remedial action undertaken to rectify all the underlying causes, as far as the downstream Gallagher Park retail estate that includes the removal of the Dead tree trunk and the Aldi store's site drainage construction across the INMC 64 footpath by CAB or CJB builders, that resulted in bank side stones each approx 1m⁽³⁾, left as debris in the river bed to negatively affect the river flows path.

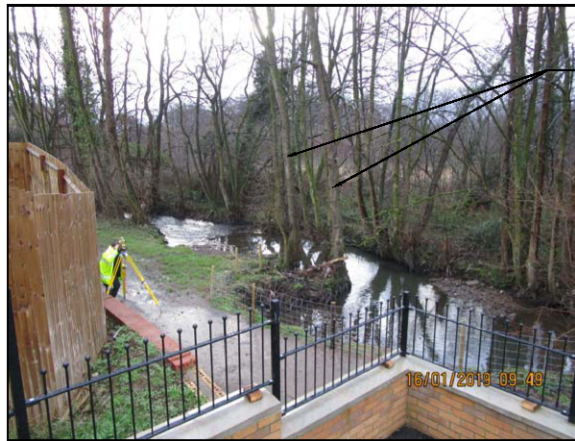
It would appear that the '*Dislodged revetment repair tree trunk*' that had lain across the river, has been manoeuvred back alongside and re-strapped to the repair.

On the right of the red hatched line, on remaining foreground soil, the over winter dead stalks of Himalayan balsam spread lie flattened from the constant river overflows, where the 2019 planned bank side repair which was then, and even now is still to low.

The author's apologies are offered, as a maculopathic eye condition that relies upon a cameras ability to set both auto focus and exposure timings, that do not appear to be correct for the picture above right.
